Phase III Investigations and Historical Study of the Spring Hill Plantation

LOCATION > Chesterfield County, Virginia

DATE > MARCH, 2015

Dutton+Associates, LLC

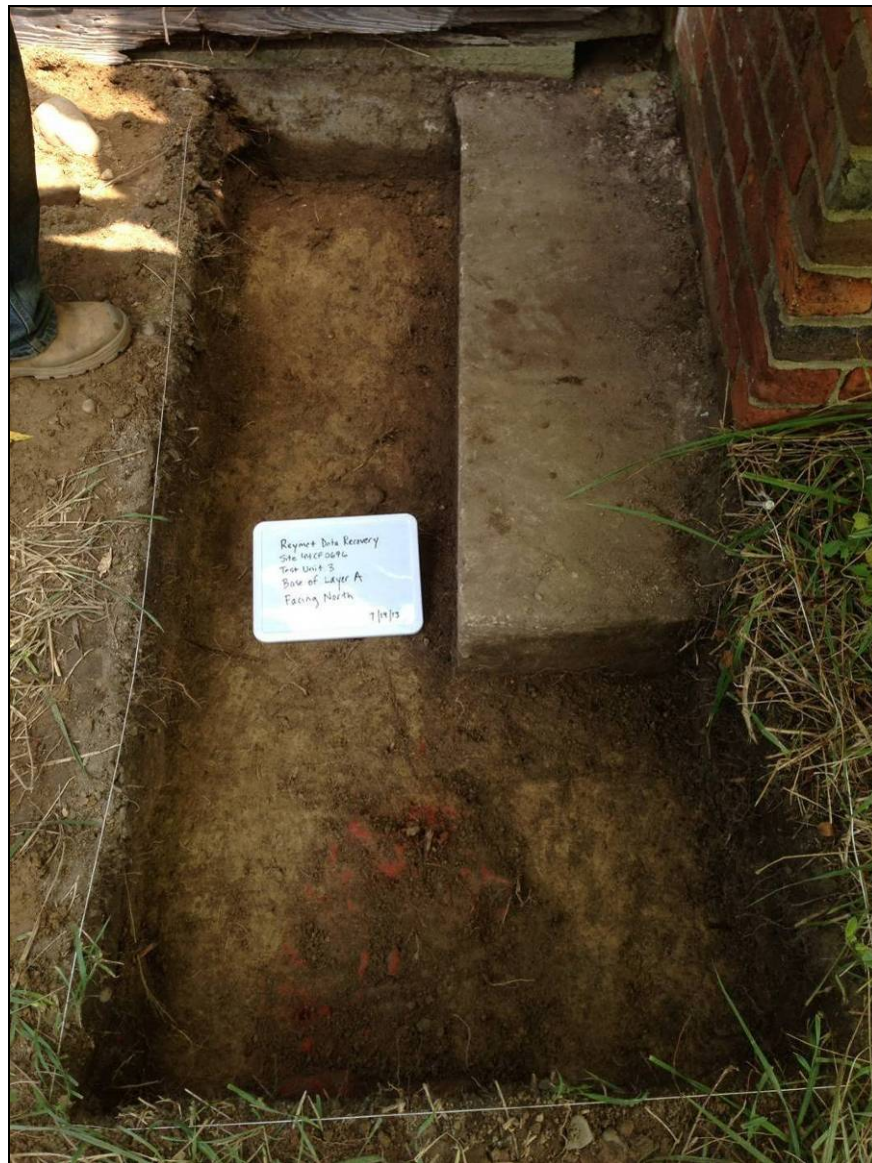
Figure 8-50. Plan view of bottom of Layer A in Test Unit 3 showing Feature 22.

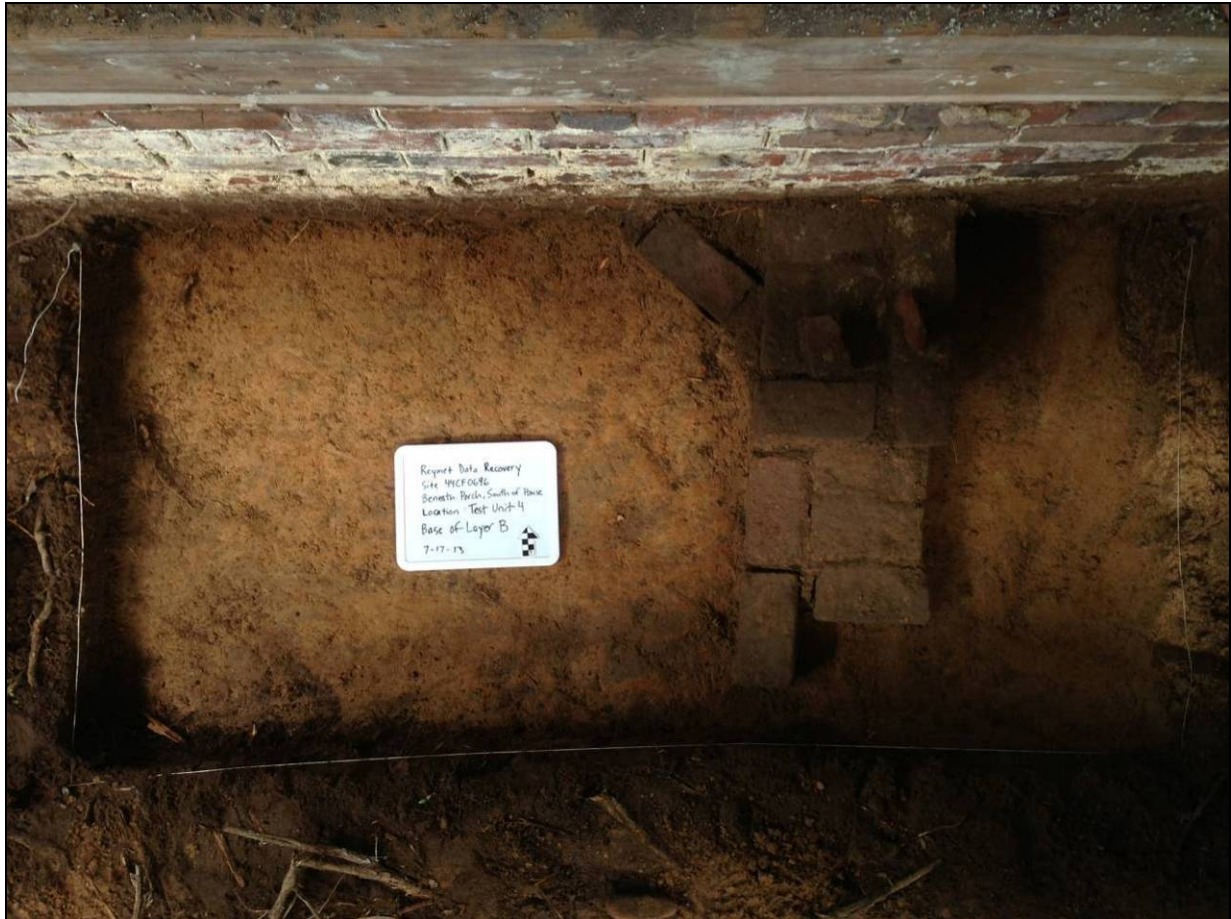
Figure 8-53. Plan view of base of Unit 4 with brick piers/stair support.

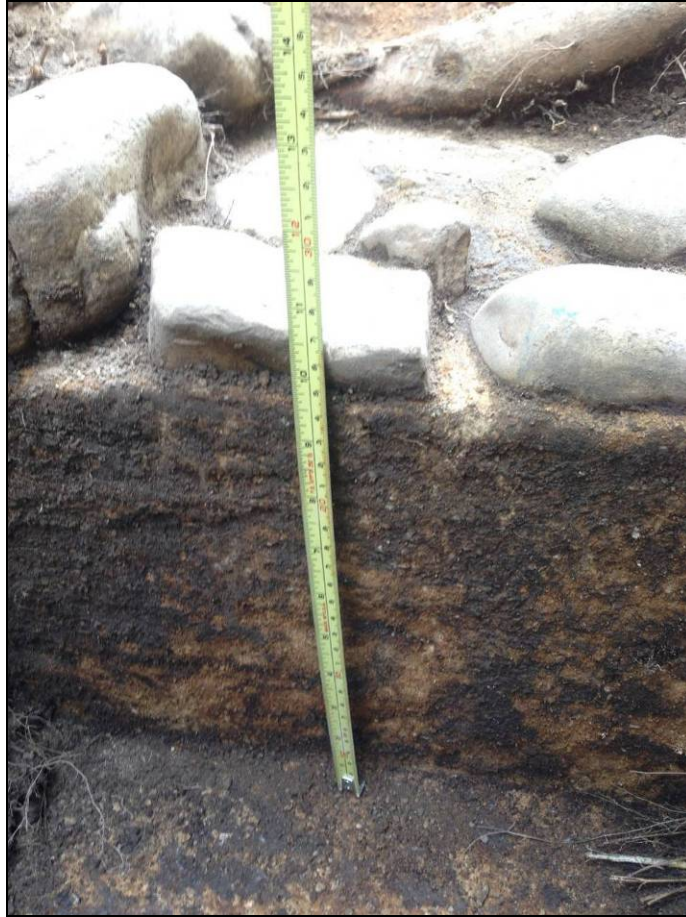
Figure 8-67. Profile view of Feature 53 with concrete foundation.

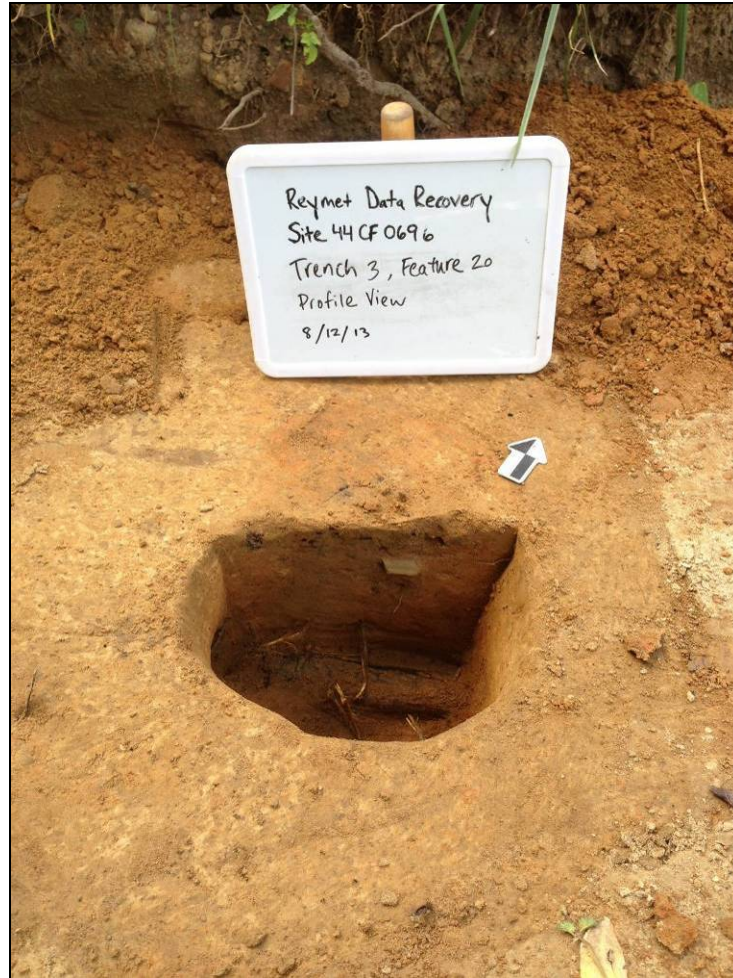
Figure 8-85. Profile view of Feature 20, Trench 3.

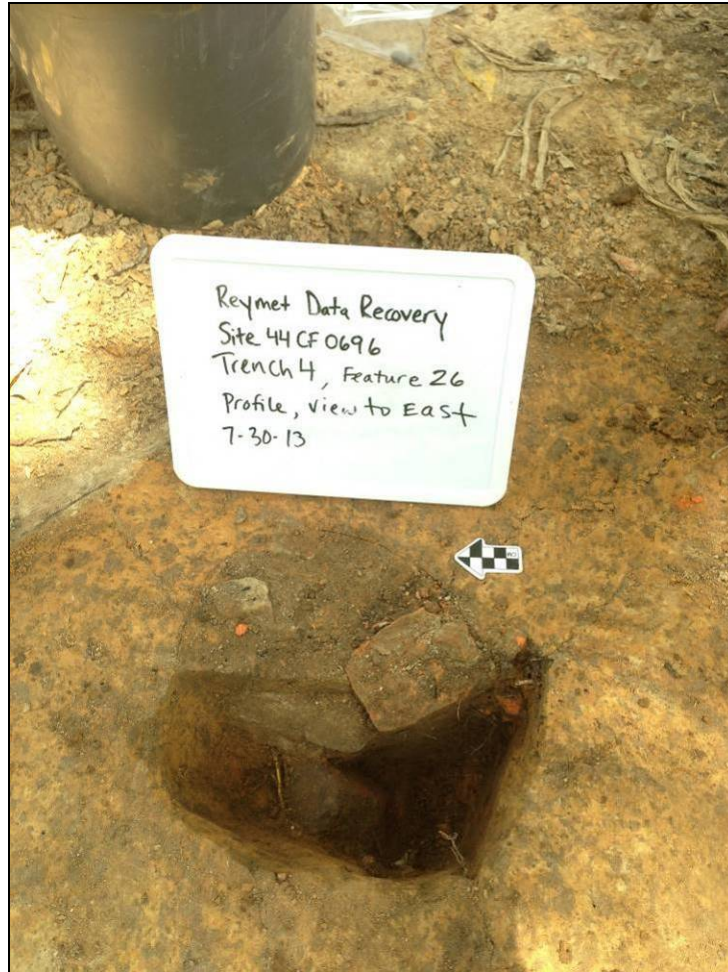
Figure 8-90. Plan and profile view of Feature 26, Trench 4.

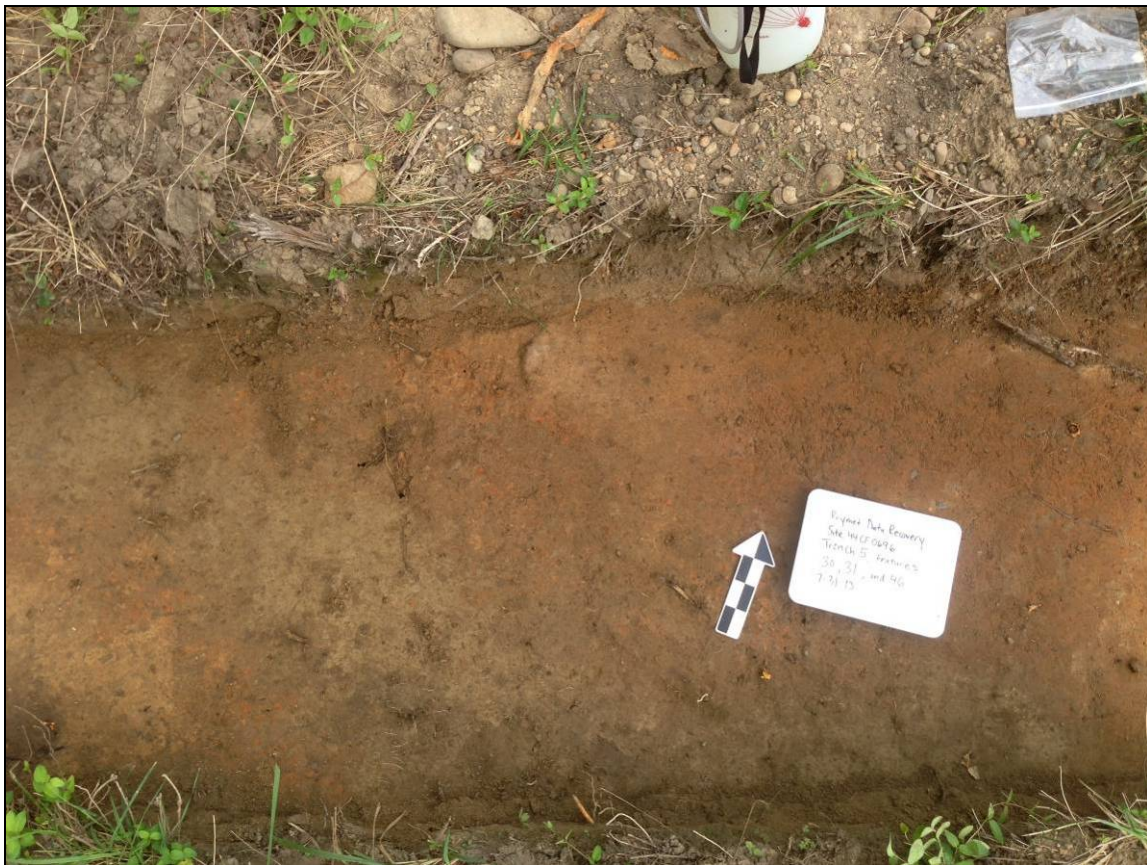
Figure 8-93. Plan view of Features 30 and 31

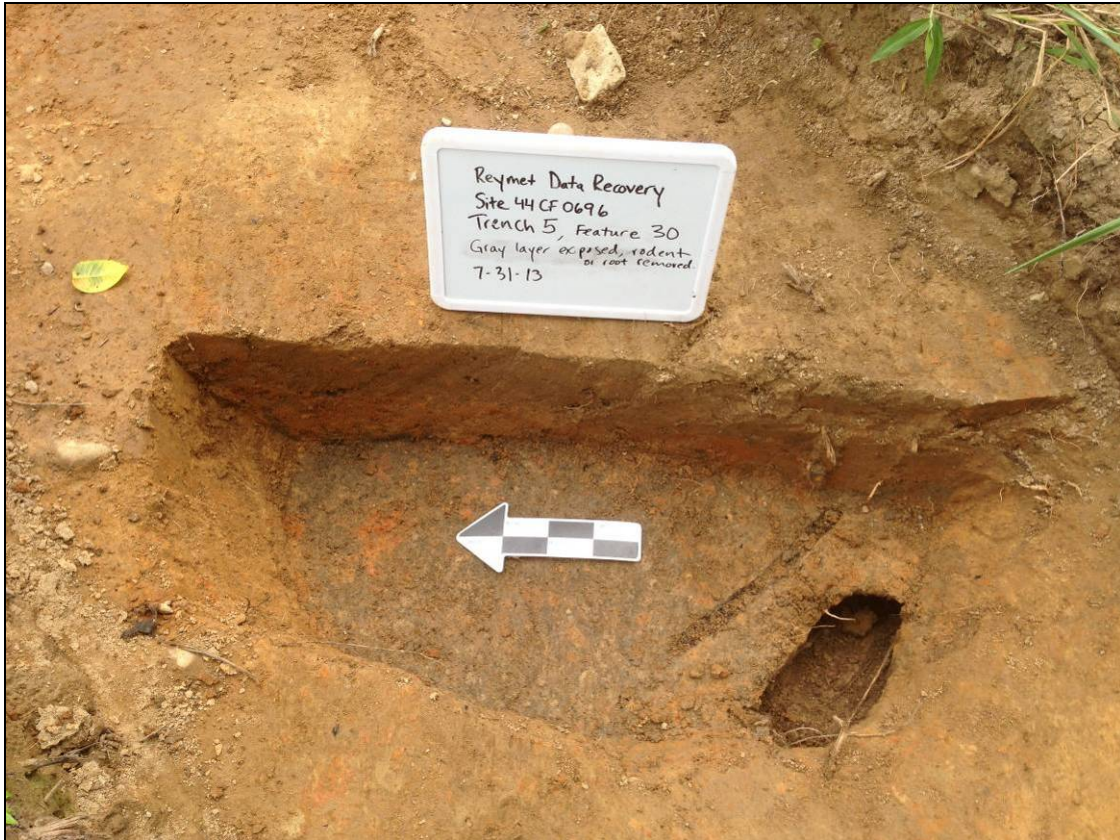
Figure 8-94. Feature 30, Trench 5, in Profile.

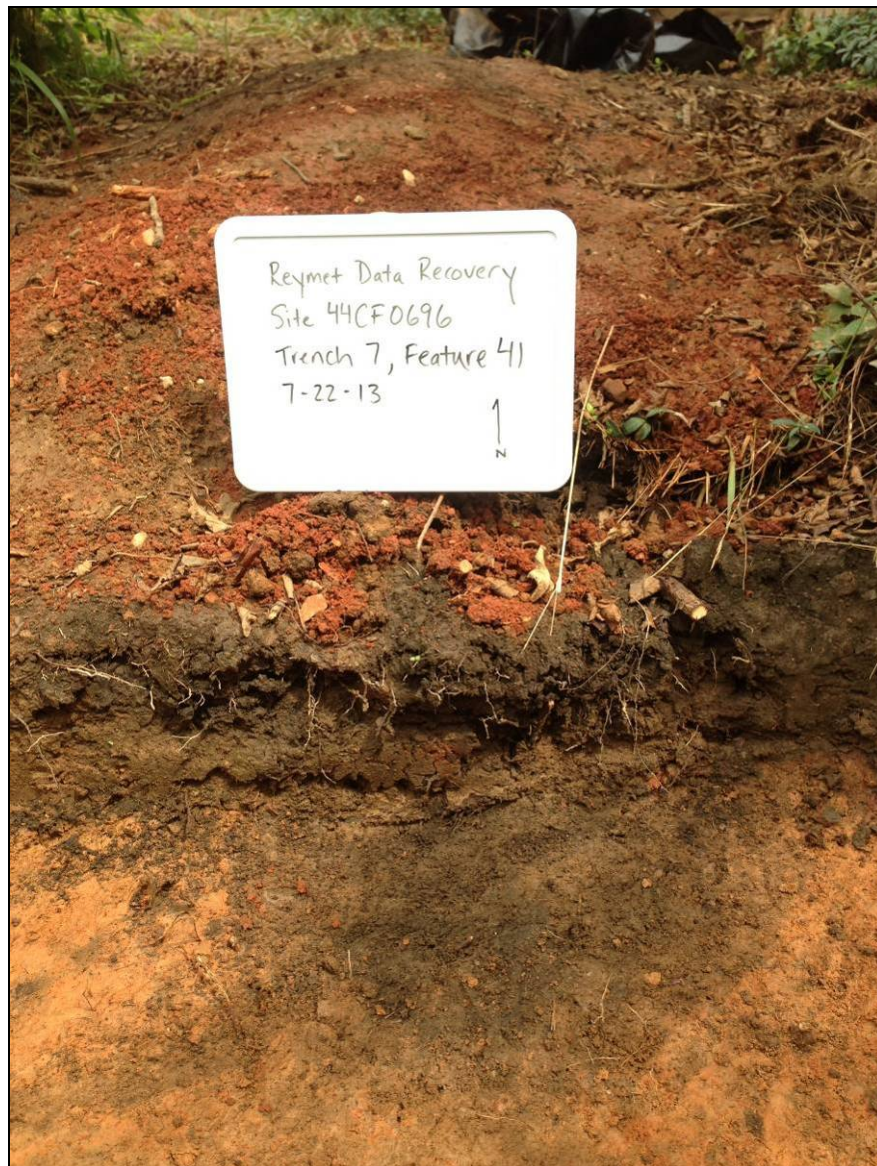
Figure 8-104. Plan view of Feature 41, Trench 7.

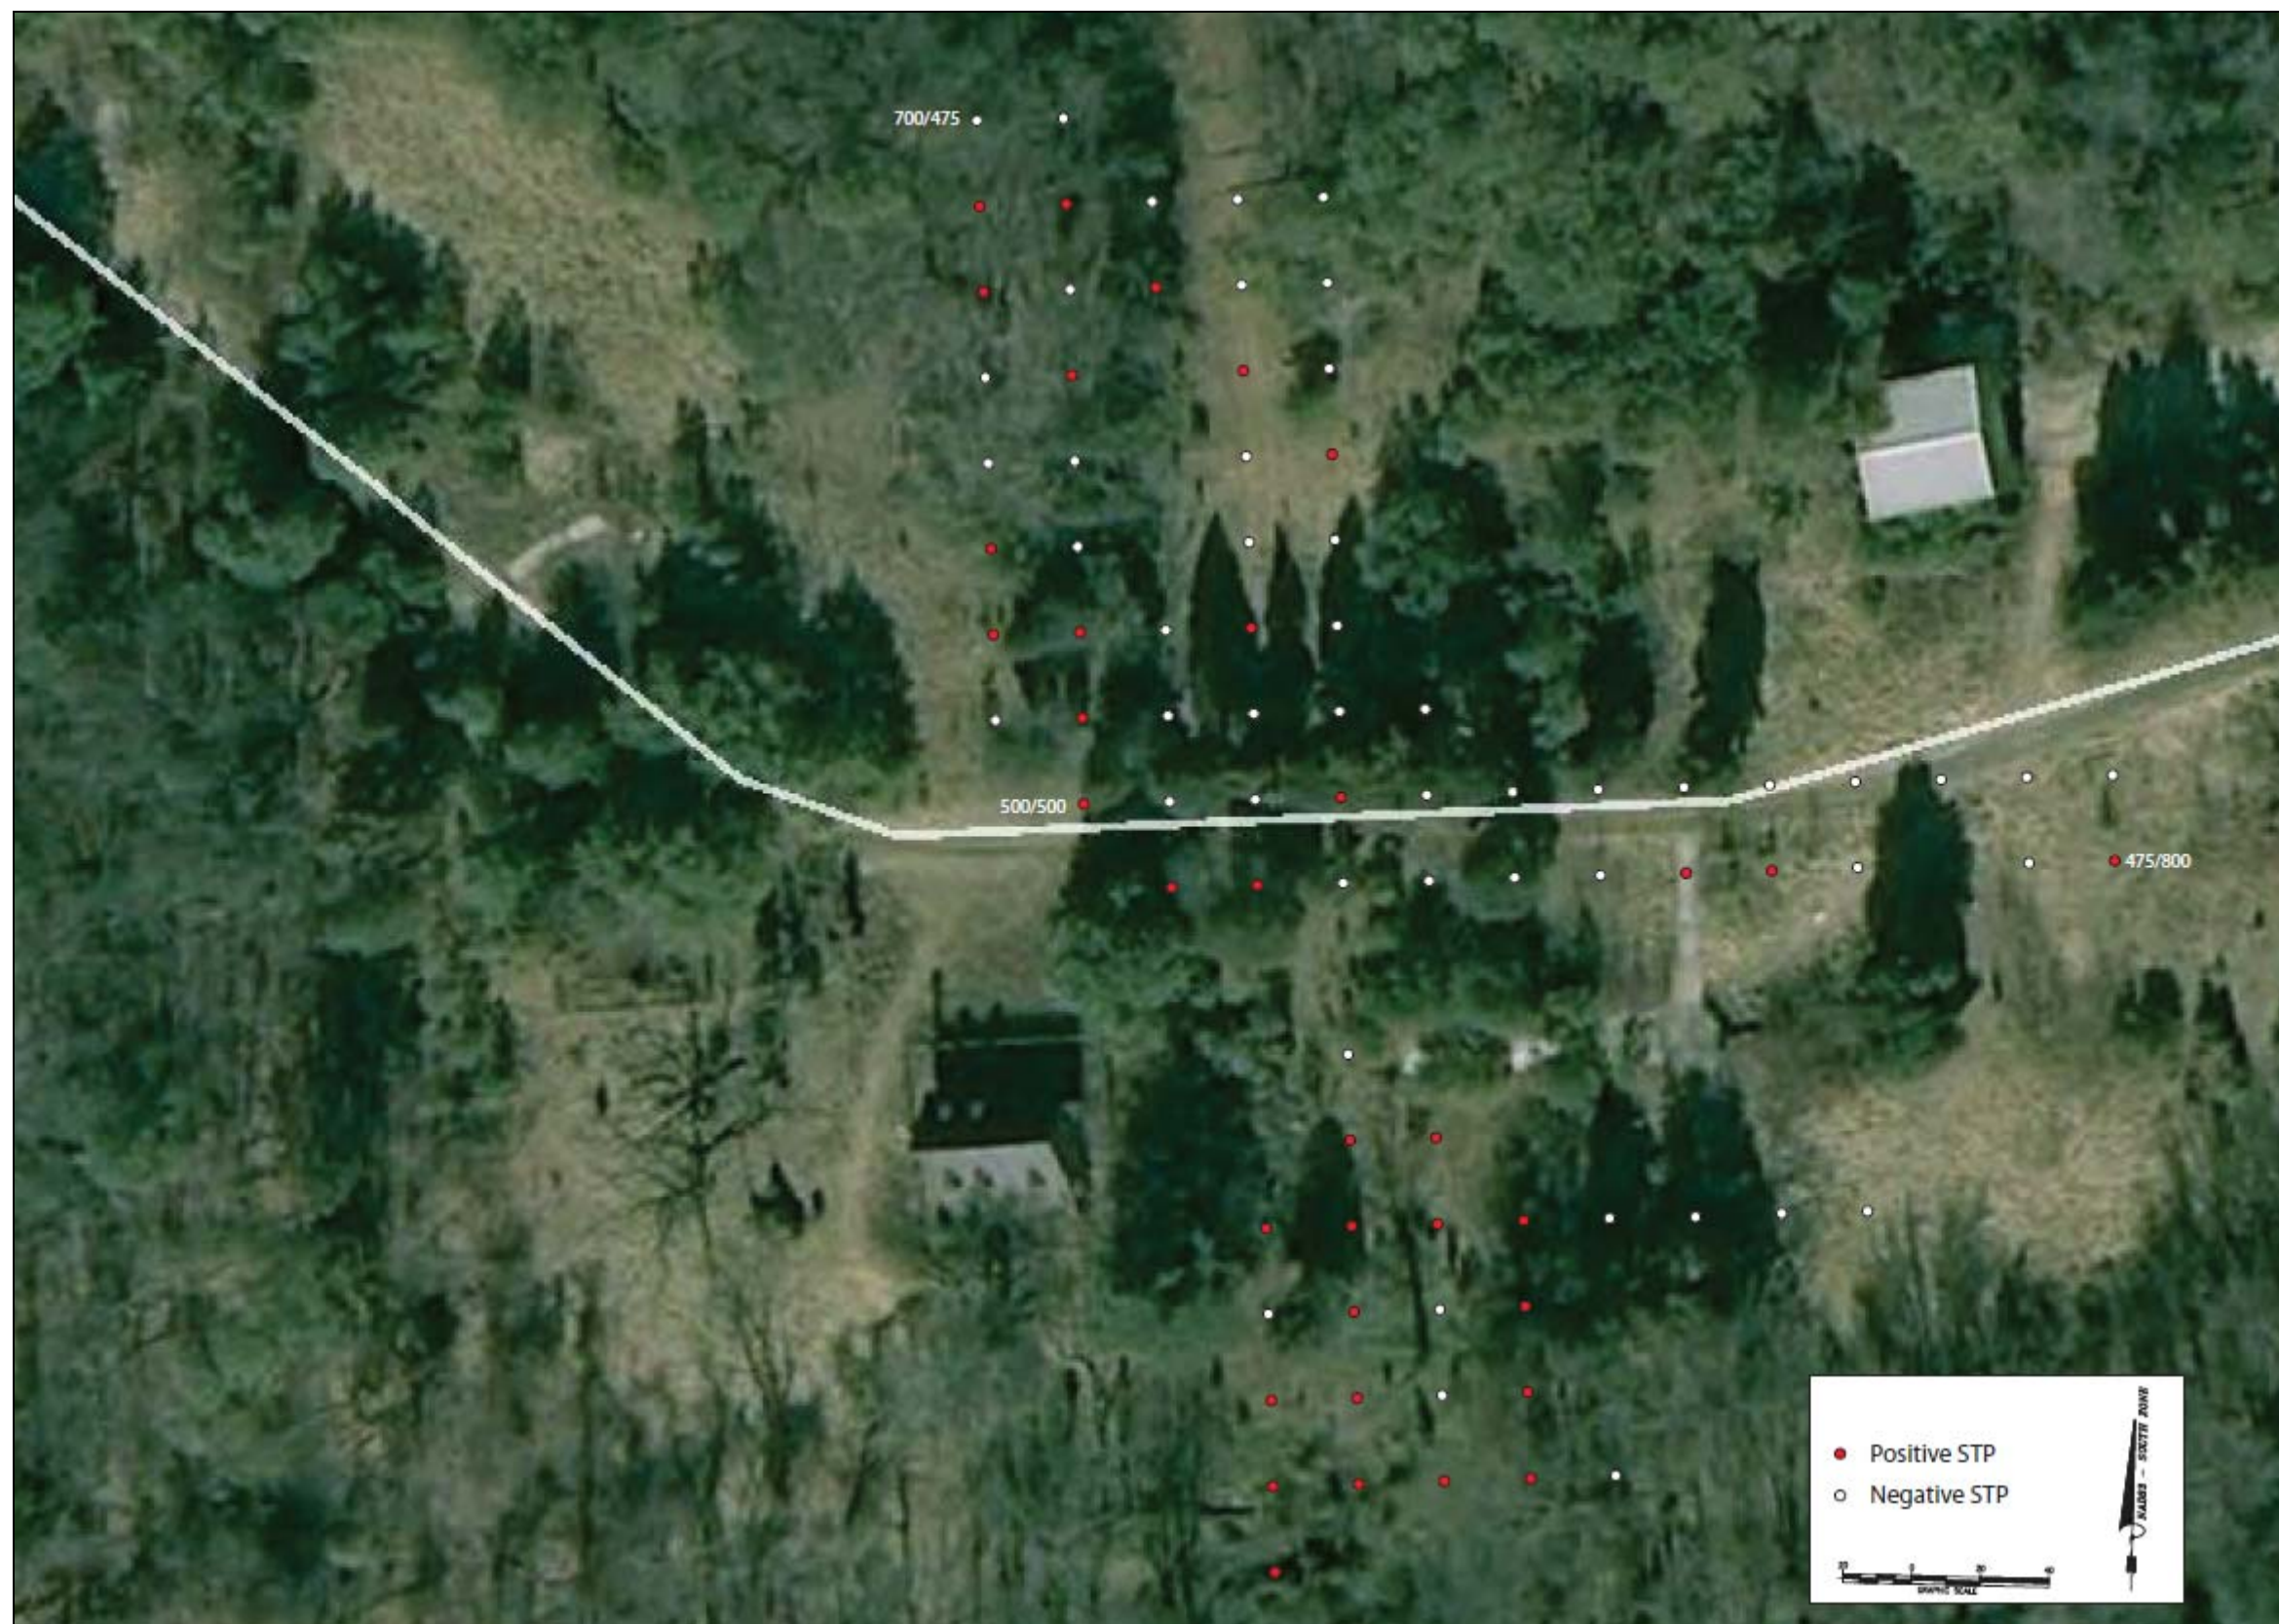
Figure 8-108. Plan view of additional shovel testing conducted during Phase III investigations of Site 44CF0696.

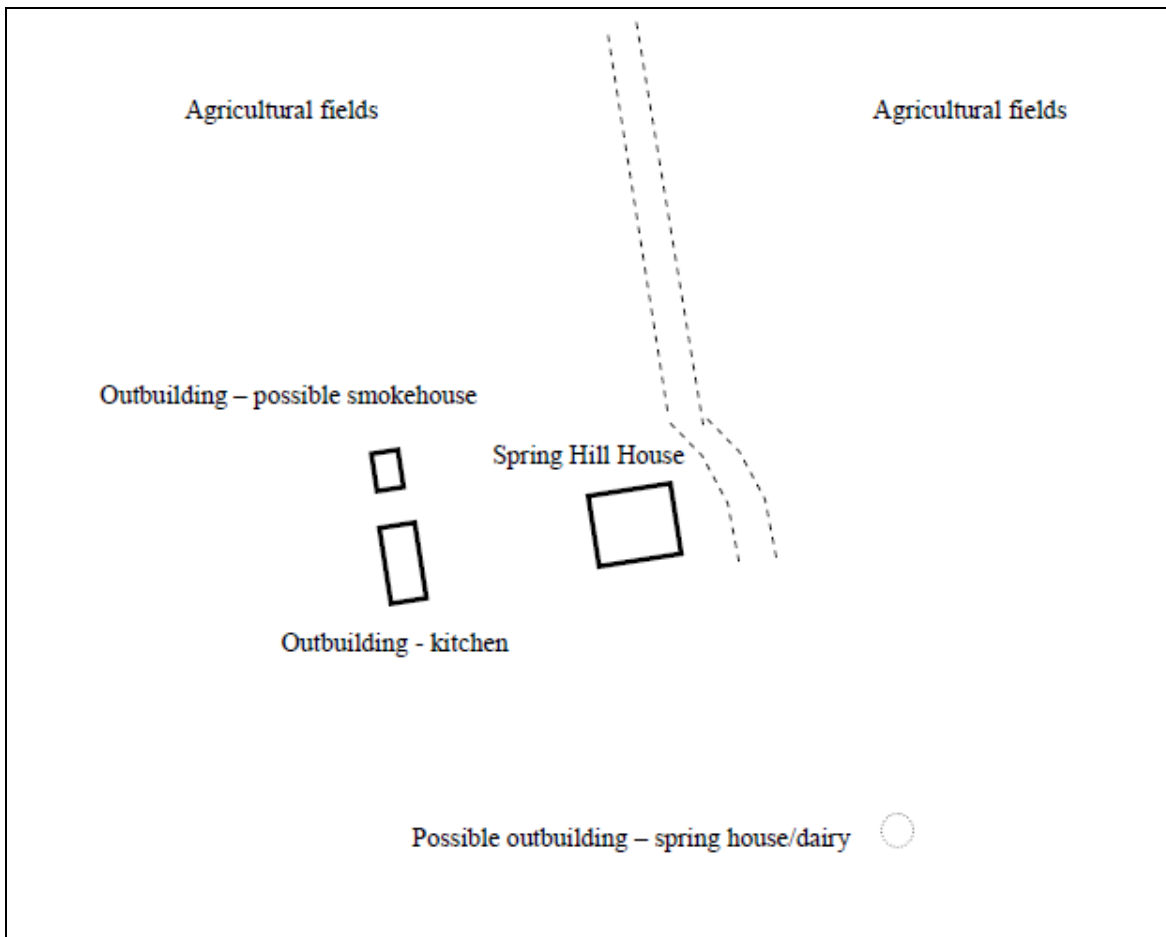
Figure 9-10. Conjectural layout of the domestic core during Cox Family occupation. Not to scale.

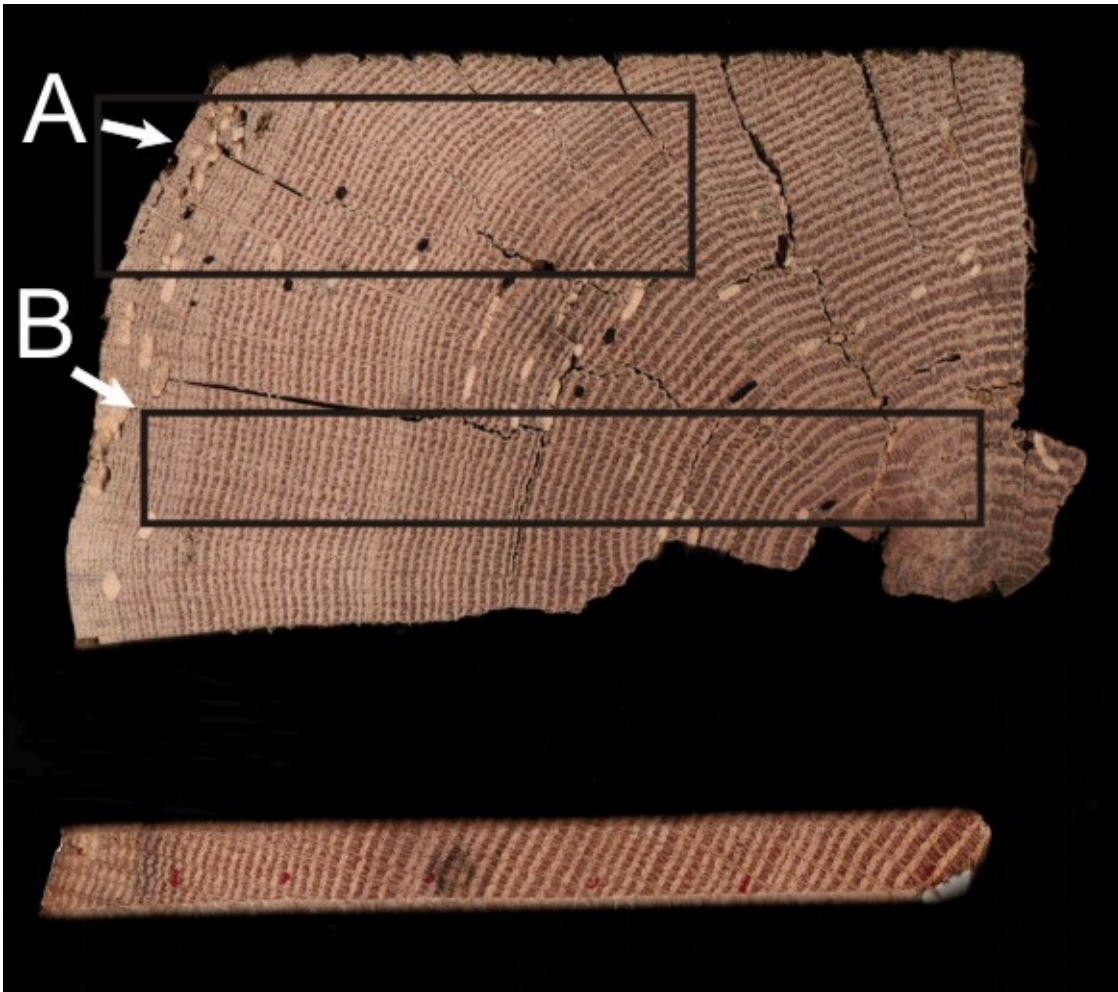
Figure 1. A cross-section of an oak timber with sapwood rings on the left-hand side (above). The boxes illustrate conversion methods resulting in **A**) a precise felling date and **B**) a *terminus post quem* or felled-after date. Also pictured is a core showing complete sapwood (below).
